Building 55

Published in:
Catalhoyuk excavations

Chapter 17

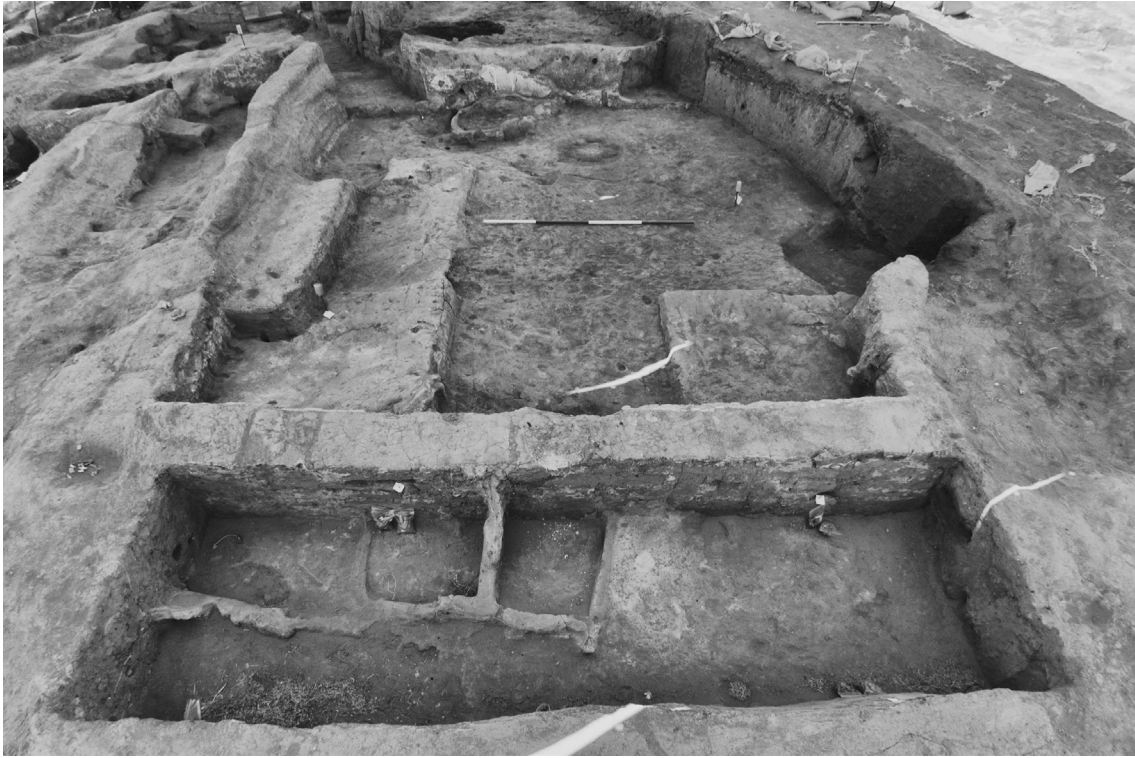
Figure 17.2. South-facing photograph of the eastern part of B.55 (Photograph by Jason Quinlan).

The main room of B.55 was large in size measuring 5.46m by 4.72m and followed many of the conventions for internal arrangement of features within buildings. The building was not fully exposed at one time as the limit of excavation initially meant that only the western part was seen. Fig. 17.2 taken facing south shows the infill of the building at this stage of excavation sealed by midden and truncated by the foundation trench for B.41. The platforms along the eastern wall and the northwest platform can also be seen with substantial slumping evident in the eastern platform presumably caused by the presence of underlying burials. Fig. 17.3 is an east-facing photograph of the same space, taken from beyond the limit of excavation; it shows the edge of the later quarry pits cutting the northwest corner of the room.

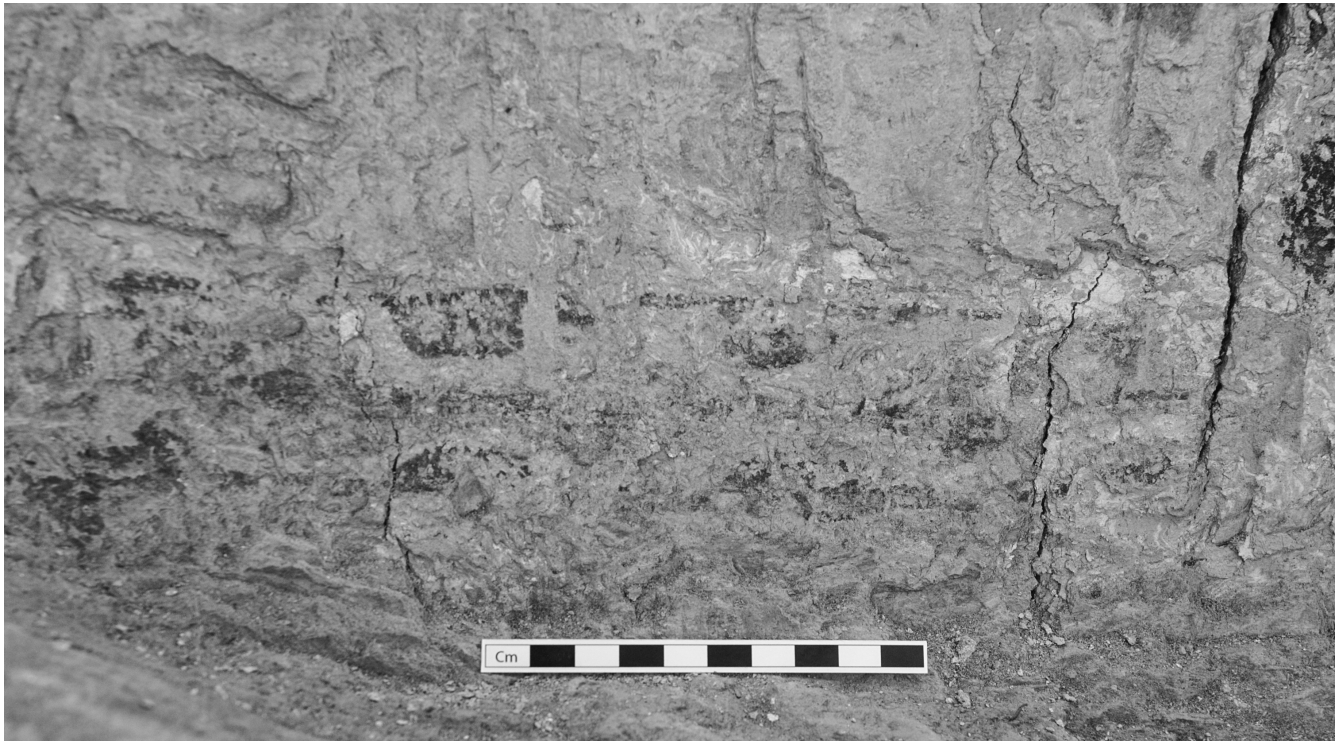
Figure 17.5. Close-up of the design painted behind the oven in B.55 on wall F.2045 (Photograph by Jason Quinlan).

walls associated with ovens and this is also the first example in the renewed excavations. Evidently it was not a common practice to decorate this wall of buildings in this manner but, nevertheless, the occupants of B.55 had frequently displayed painted motifs above the oven. The final plaster layer, visible when the building was abandoned, was painted with a either a partly flaked away solid red design or, more likely, a series of red blocks forming a linear pattern (Fig. 17.5).

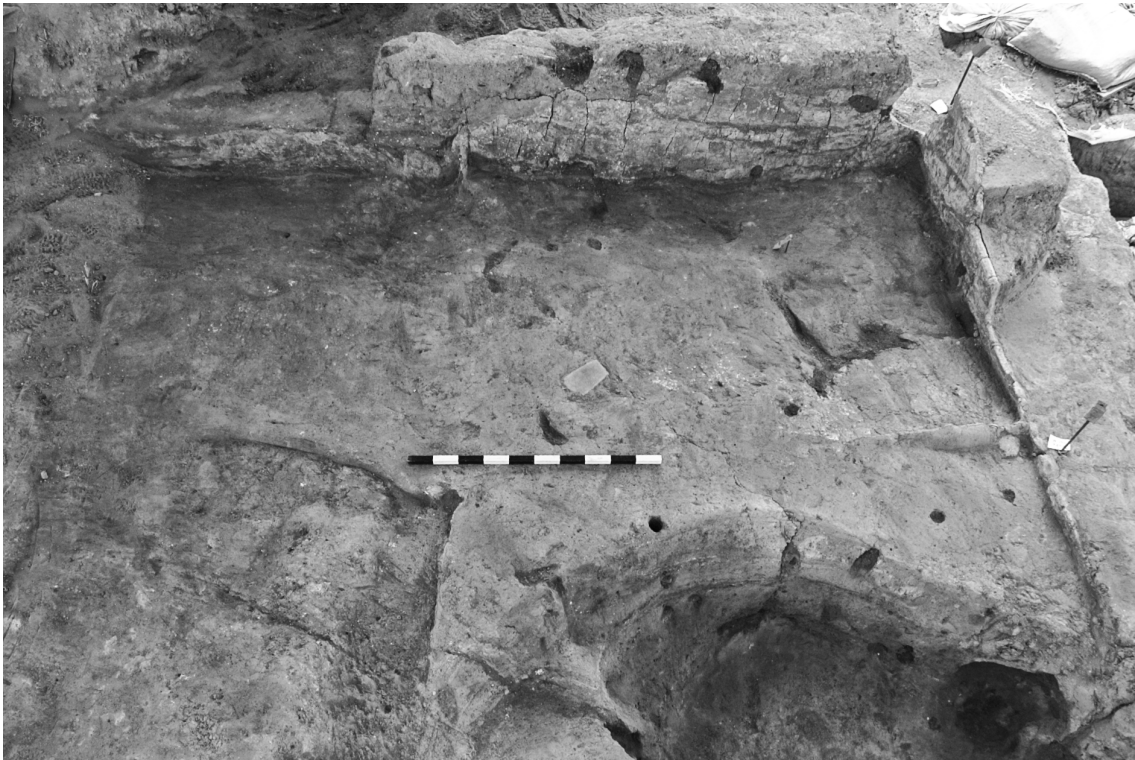
Figure 17.8. South-facing photograph of Sp.322 with thick floor sequence in the foreground truncated by quarrying and stone set into floor (Photograph by Jason Quinlan).

It is not certain, therefore, if this feature was a bin or a basin where grinding or other food preparation could have taken place. A flat stone set into the floor surface in the central part of the room can be seen in Fig 17.8.

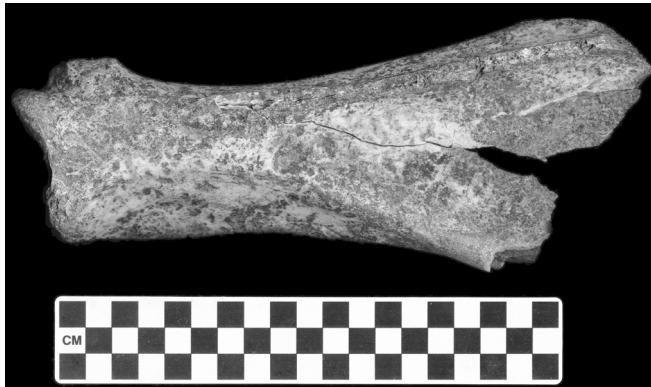
Figure 17.10. Pre-form 10326.x4 of a scapula tool (Photograph by Faunal Team).

The roomfill in Sp.247 was relatively homogenous and towards the base of the infill deposits were a number of finds probably left in the room when it was abandoned; these were excavated from the interface of the feature surfaces and infill deposits. The eastern side of the infill (10326) contained many fragments of mudbrick collapse and lower in the fill was a concentration of bones as well as a number of stones. Of these, 10326.x1 is part of a large cattle horncore and 10326.x4 is a cattle scapula that is a preform for a scapula tool. The spine of the scapula had been removed and the scar pecked even (Fig. 17.10). The tool, however, is not complete but it could eventually have been used as a shovel for removing food-stuffs kept in the bins. 10326.x4 is a large piece of cattle horncore including some of the frontal and maybe two-thirds of the horncore.

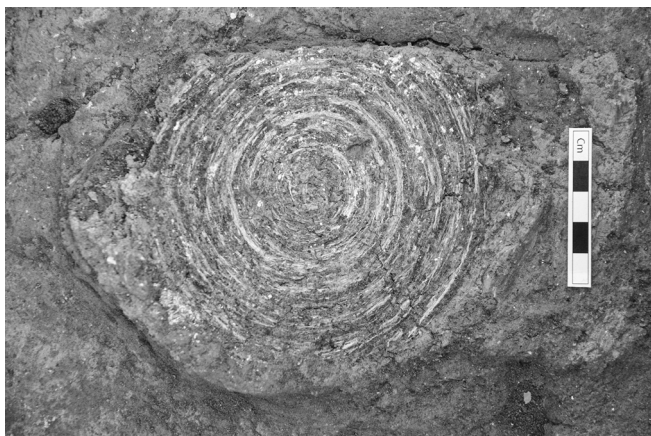
Figure 17.12. Phytolith impression (12304) of a mat or basket left on the northeast platform (Photograph by Jason Quinlan).

Sp.256 was fairly well cleared out before the abandonment of the building and the room started to infill (10395/12301/12309). The only trace of anything left on the floors was on the northeast platform F.2049 that had been abandoned with a basket or mat left on its surface leaving behind the phytolith impressions (12304) of its base (Fig 17.12). All of the infill deposits were relatively sterile and no concentrations of finds were found above the floors. After this initial infilling the post against the northern wall was dug out (12312) and the cut filled with compact clay (12310). Unusually, no specific finds were found in the base
